Home Inspection Report

123 Somewhere Street
Yourtown, US 12345

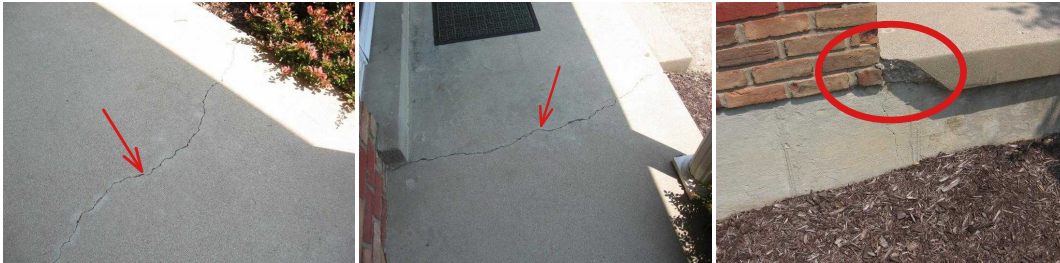
- 1. Acceptable Driveway: Concrete
- 2. Acceptable Walks: Concrete
- 3. Defective Porch: Concrete - **Settling away from foundation with surface cracks noted**

1. Porch: Concrete - **Settling away from foundation with surface cracks noted**

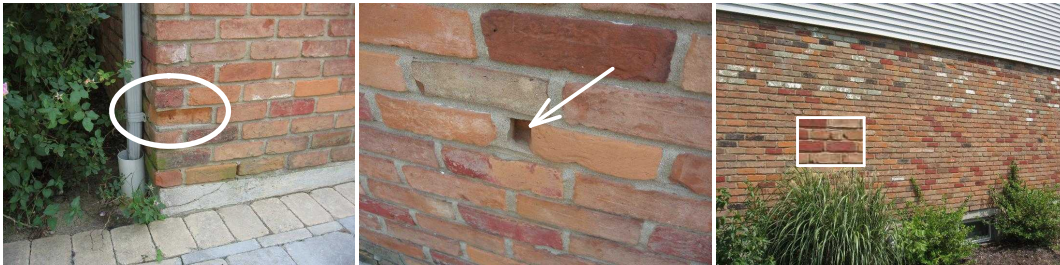
- 1. Marginal Type: Brick veneer - **Some damaged bricks, Recommend sealing brick with penetration sealer products**

2. 1st Floor Exterior Surface Type: Brick veneer - Some damaged bricks, Recommend sealing brick with penetration sealer products

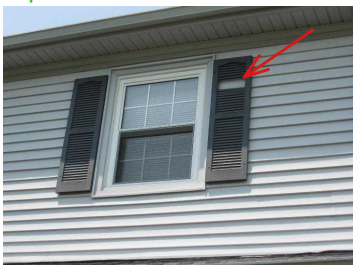
- 2. Marginal Type: Vinyl siding - **Damaged front shutter, Chalking noted due to age, One panel needs to be repositioned at rear elevation**

3. 2nd Floor Exterior Surface Type: Vinyl siding - Damaged front shutter, Chalking noted due to age, One panel needs to be repositioned at rear elevation

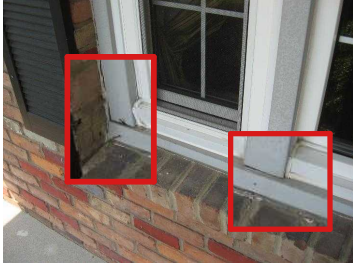
- 5. Marginal Soffits: Vinyl - Loose/sagging at front porch
- 6. Acceptable Door Bell: Hard wired
- 7. Acceptable Entry Doors: Wood
- 8. Marginal Patio Door: Vinyl sliding - Resecure loose handle hardware, Screen damage noted
- 9. Marginal Windows: Vinyl insulated - Reseal caulking at window perimeters at brick window openings

4. Trim: Aluminum - Chalking noted due to age, Loose nails in areas
5. Soffits: Vinyl - Loose/sagging at front porch
6. Patio Door: Vinyl sliding - Resecure loose handle hardware, Screen damage noted
7. Windows: Vinyl insulated - Reseal caulking at window perimeters at brick window openings

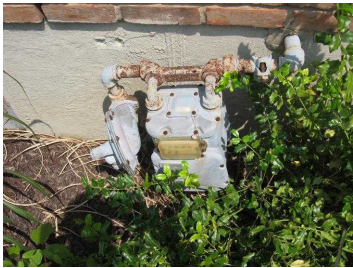
- 10. Acceptable Window Screens: Metal
- 11. Acceptable Exterior Electric Outlets: 110 VAC GFCI
- 12. Marginal Hose Bibs: Gate - Properly secure fixture(s) to exterior wall with fasteners
- 13. Acceptable Gas Meter: Exterior surface mount at side of home - Rust present, Keep bushes and shrubs away from meter

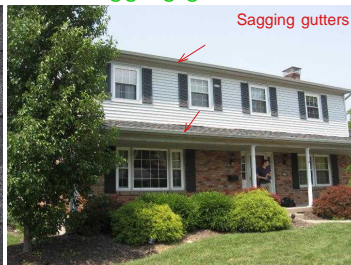
- 1. Method of Inspection: Ladder at eaves
- 2. Acceptable Material: Fiberglass shingle
- 3. Type: Gable
- 4. Acceptable Flashing: Metal
- 5. Acceptable Plumbing Vents: Copper
- 6. Acceptable Electrical Mast: Underground utilities
- 7. Marginal Gutters: Aluminum - Loose nails, Sagging gutters at front and rear

9. Gutters: Aluminum - Loose nails, Sagging gutters at front and rear

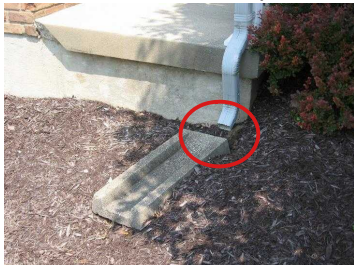
- 8. Acceptable Downspouts: Aluminum
- 9. Marginal Leader/Extension: Splash blocks - **Splash block(s) not properly installed**

10. Leader/Extension: Splash blocks - **Splash block(s) not properly installed**

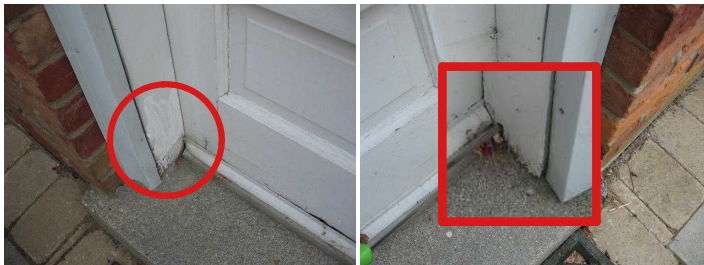
- 1. Type of Structure: Attached Car Spaces: 2
- 2. Acceptable Garage Doors: Insulated aluminum
- 3. Acceptable Door Operation: Mechanized
- 4. Acceptable Door Opener: Overhead Door
- 5. Acceptable Exterior Surface: Brick veneer
- 6. Acceptable Roof: Asphalt shingle
- 7. Acceptable Roof Structure: 2x6 Rafter
- 8. Defective Service Doors: Wood - **Wood rot at bottom of door and frame**

2. Attached Garage Service Doors: Wood - **Wood rot at bottom of door and frame**
